ENTIAT

CO-OPERATIVE RIVER BASIN STUDY

Cooperative River Basin Study

April 1979

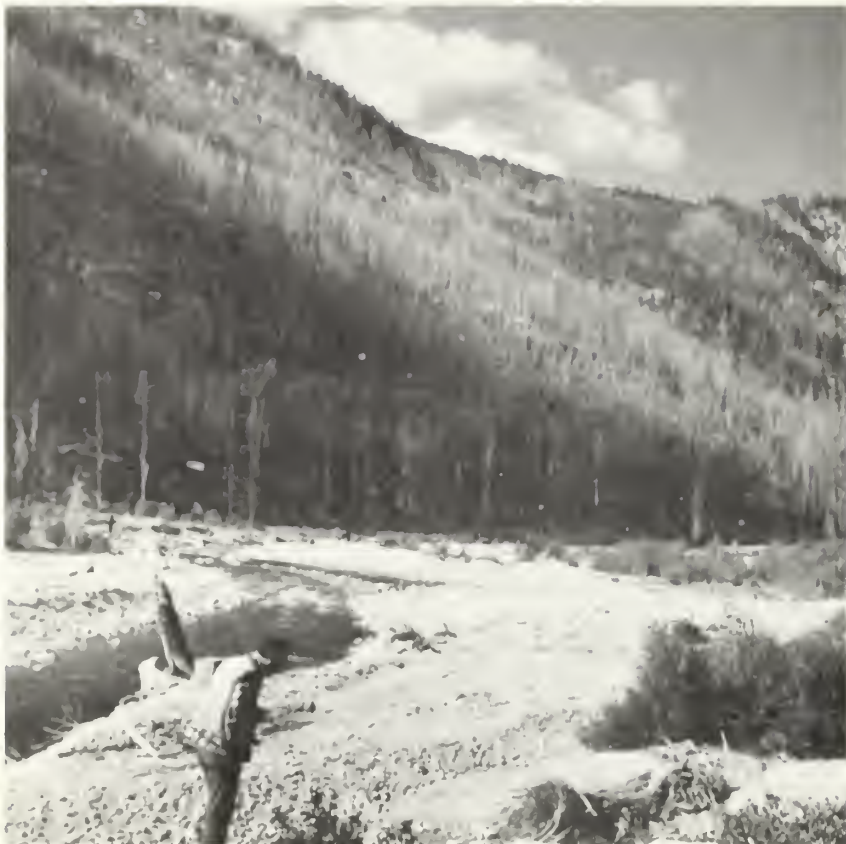
Brush plantings such as willow will help stabilize much of the Upper Entiat floodplain.

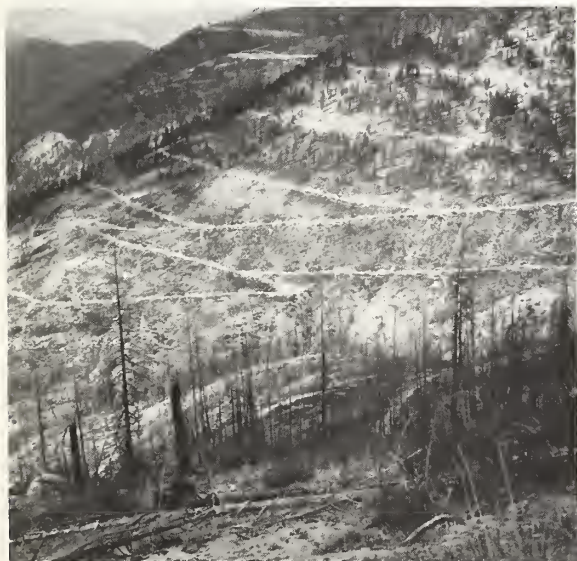
Jammer road system, exposed by the Burn, enabled salvage following the 1970 fire. 90 million board feet of timber were recovered from salvage logging effort.

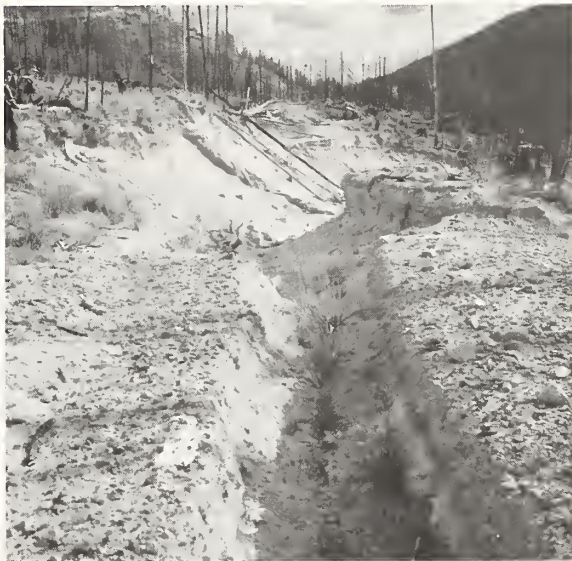
Mass movement in pumice soils has been accelerated by road runoff.

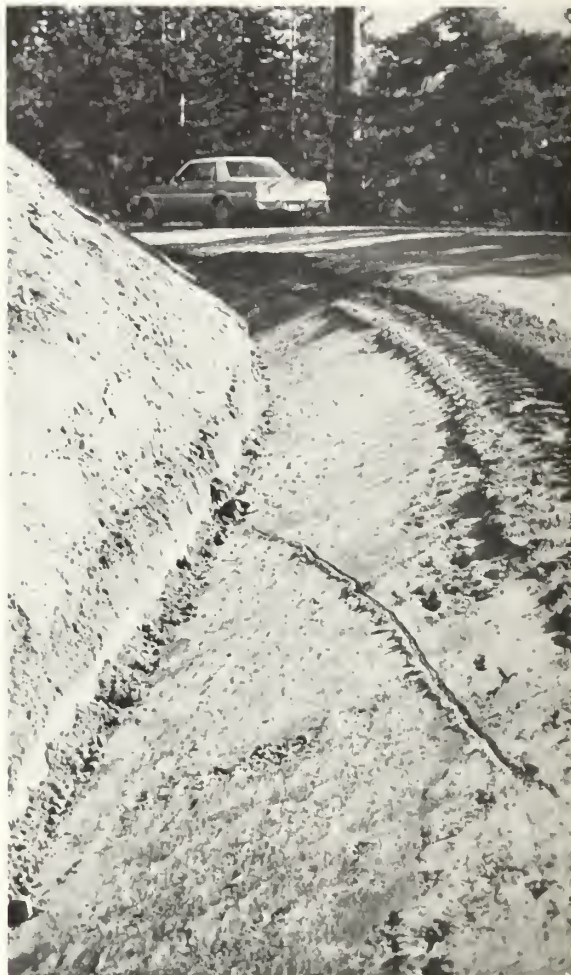
Cutting the toe of slope with road grader will cause accelerated erosion due to new unstable angle of repose.

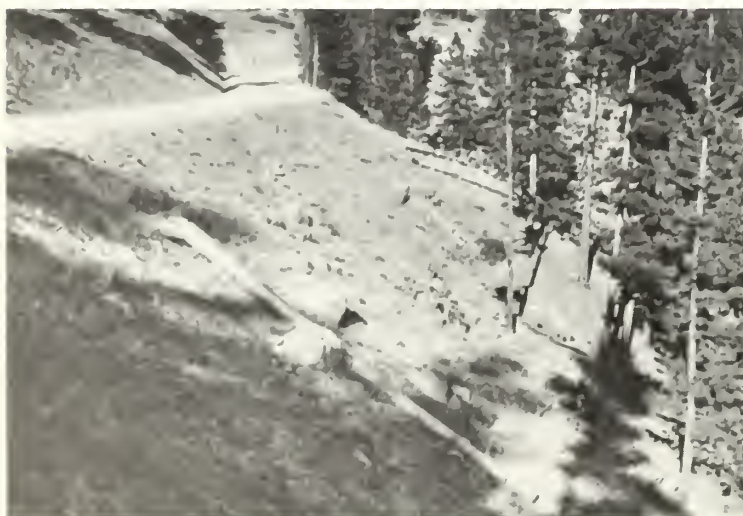
Excellent effort to minimize erosion of road fill slope in the Mad River Watershed by piping water down slope.

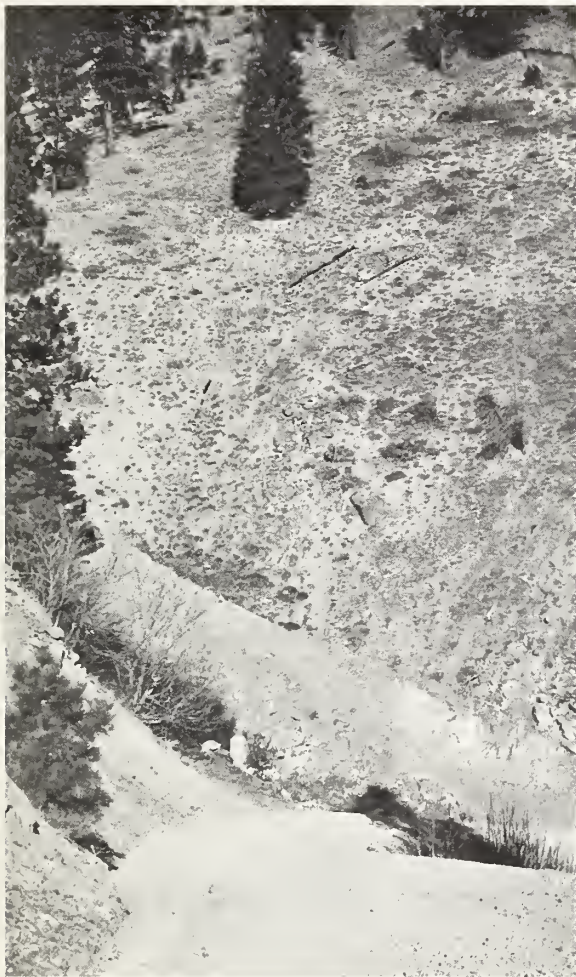
This area is typical of dry creep, colluvial erosion process that occurs on steep slopes.

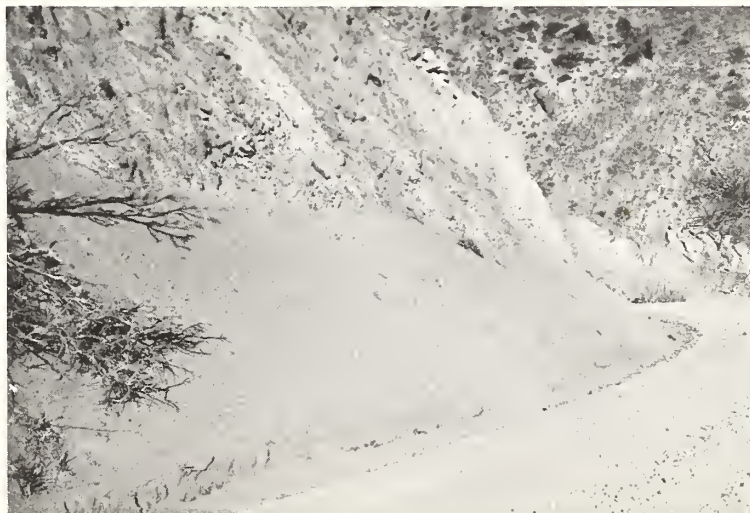
Dry creep erosion is a major source of road cutbank erosion. Often fall rain carries much of this material into live streams.
